APPENDIX A STRUCTURAL ANALYSIS

ARCHITECTURAL ASSESSMENT

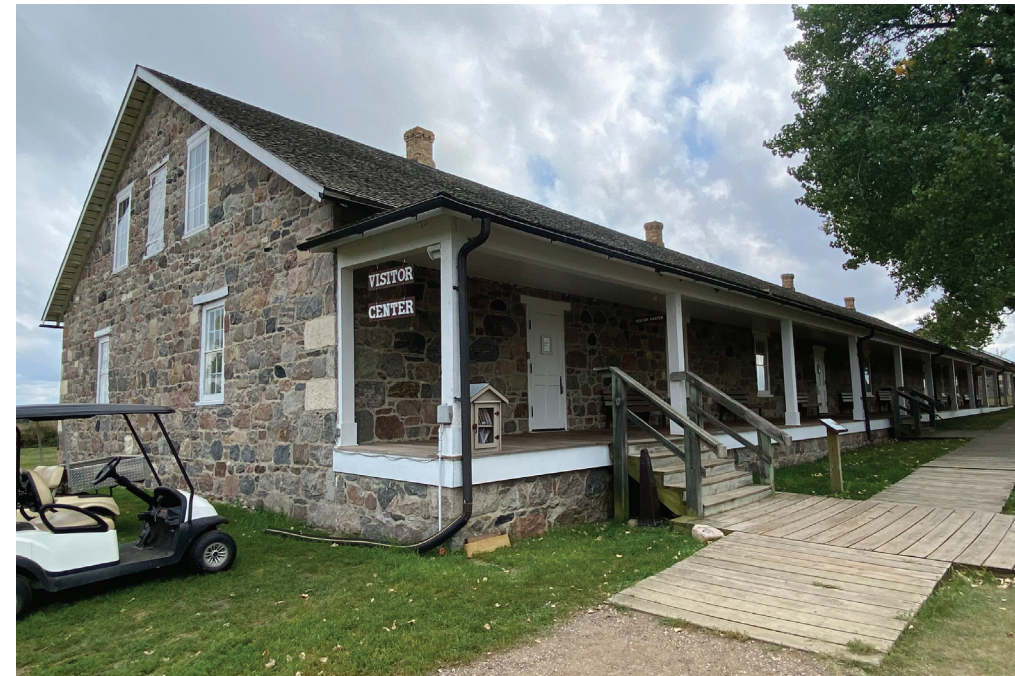
NORTH BARRACKS

The North Barracks was a dormitory, company kitchen, dining hall and washroom. In 1883, coal-heated bath houses were constructed in the rear of the barracks. The front porch was added in 1885. The barracks was intended to accommodate two companies of soldiers (50 enlisted and 3 officers per company), though it initially housed double that target capacity (four companies, or 200 enlisted and 12 officers). The number of companies in the barracks dropped to three in 1867, and dropped to two in 1869. When the WPA people came in 1935, only the outside walls and fragments of the inside walls were still standing. Today, this structure houses the visitor center, museum, gift shop, restrooms, and presentation areas.

- Replace rotted windows
- Tuckpointing exterior of the building
- Replace cedar shingle roof, gutters, and fascia
- Repair/replace stoop by employee break room
- Repair plaster cracks and water damage by exhibits, bunk room, and kitchen
- Repair uneven floor throughout building
- Remove carpet

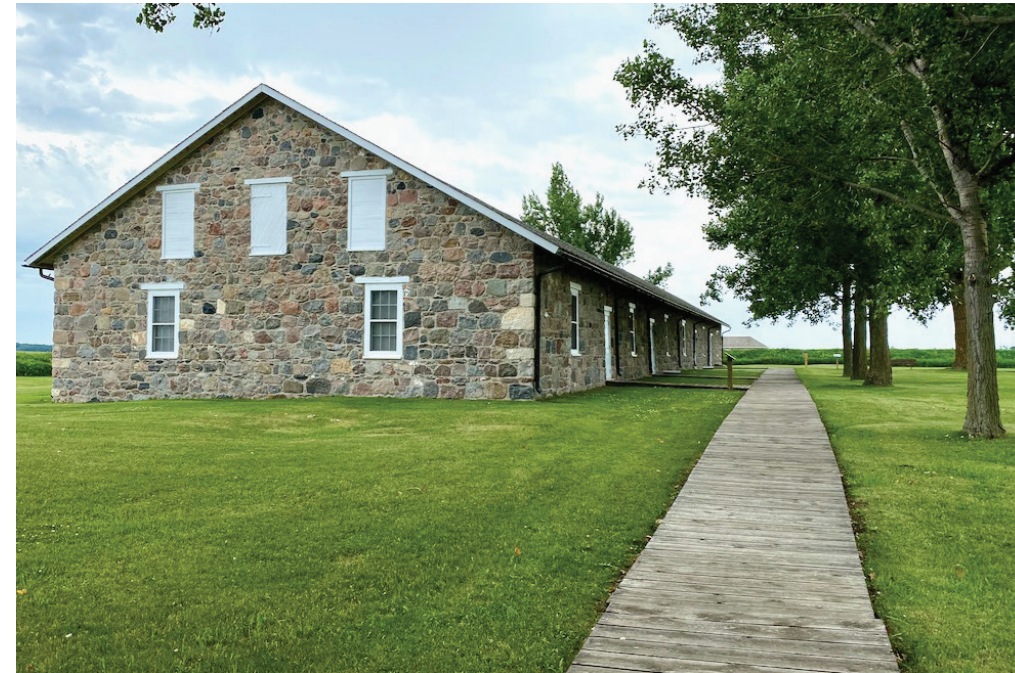
SOUTH BARRACKS

The South Barracks is the same size as the North Barracks, though the South Barracks has never had an attached porch. The South Barracks did have a partial cellar in the southwest portion. As the number of companies at the Fort decreased, the South Barracks stored the Commissary and Quartermaster's goods starting in 1873. This structure housed a full year's worth of provisions for the Fort, as the closest commissary storehouse was in St. Cloud, MN, nearly 200 miles east. By the 1930s, the south wall was completely gone, and the east and west walls were partly destroyed. The WPA fixed the walls, replaced the roof with a different design, and added a concrete floor. Today, the South Barracks hosts annual events, weddings, plays, family reunions, and more.

- Repair fascia, straighten gutters, and reshingle roof
- Replace rotted windows
- Replace stairs on east side of the building
- Add electrical service
- Replace stage to comply with ADA standards.
- Repair floor trim in kitchen.
- Replace handicap stall in women's restroom due to cracks.
- Repaint south door
- Tuckpointing exterior and interior of the building

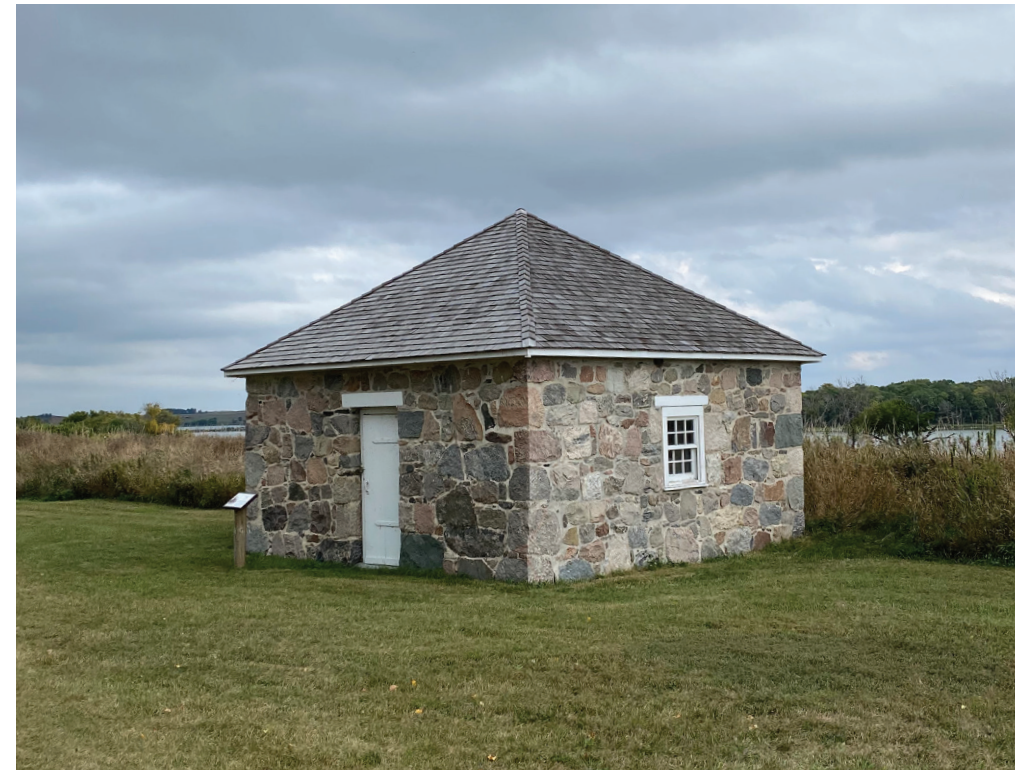
OIL HOUSE

Minor tuckpointing work is required throughout the structure. A specialist is required for this work. The stonework should be cleaned thoroughly for better ongoing observation of issues.

Located directly behind the South Barracks, the Oil House was completed in 1888. The primary use for the building was to store oil-based supplies for the duration of the Fort's active commission. Records indicate the Oil House was the final structure built at Fort Sisseton as part of the military occupation. The Oil House serves as storage today and is not open to the public.

- Replace rotted windows
- Tuckpointing of building exterior
- Repair cracks in plaster ceiling
- Repair cracked door

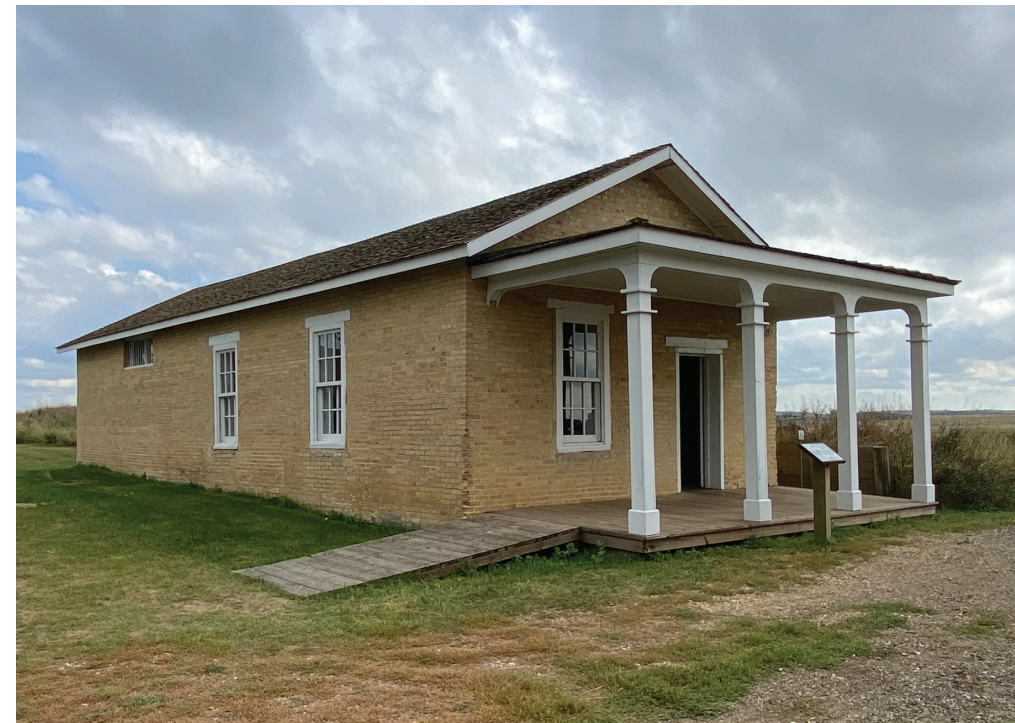
GUARD HOUSE

The west wall requires significant tuckpointing work. A specialist is required for this work.

The Guardhouse was built with two rooms for the guards and two cells for prisoners. Both cells measure four by eight feet with only a small opening atop the cell doors for ventilation. The second, non-heated room later became another open cell for soldiers awaiting punishment or sentencing. Prisoners slept on the floor as no bedding was provided. The massive bed in the main room could sleep up to eight guards, and was tilted up at the head to reduce the impact of the respiratory disease tuberculosis (TB). After becoming a State Park, caretakers added a glass window over the bars in the outside wall.

- Tuckpointing of building exterior and interior
- Replace cedar roof
- Oil porch
- Replace rotted windows

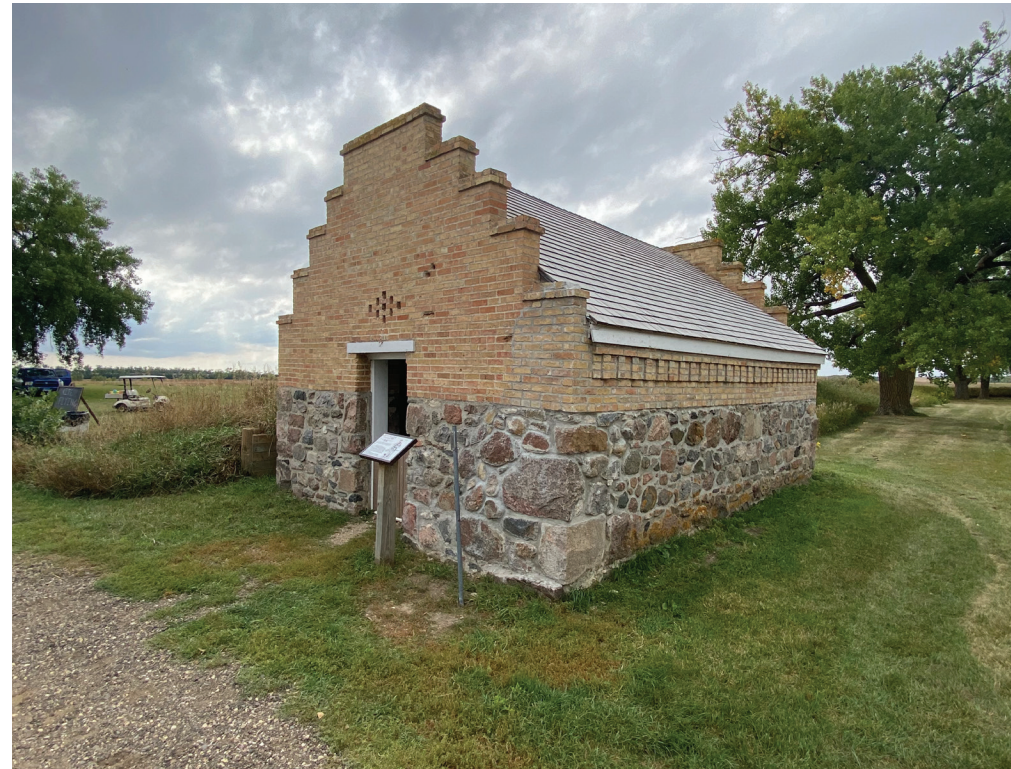
MAGAZINE

Recent repairs have bolstered this structure substantially, though some of the brick faces are spalled. Continue monitoring for further spalling and other signs of damage / deterioration.

The magazine is built of stone and brick and was used to store small arms, ammunition, canister shot, and powder for the artillery equipment. The curved ceiling and dirt floor may have helped reduce overall damage in case of an explosion. In the 1920s, the lessees of the Fort grounds converted the magazine into an ice house. A vent hole was cut through the vault at that time.

- Reseal cedar shingles on roof

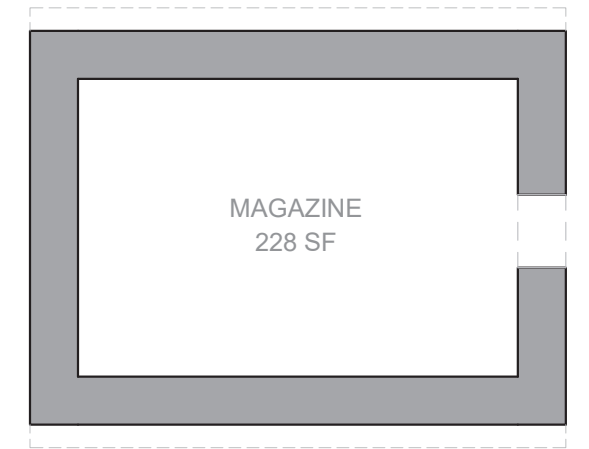
FIRST FLOOR PLAN

Minor tuckpointing work is required throughout the structure, though the southwest corner likely requires extensive tuckpoint work. A specialist is required for this work. The floor framing should be replaced.

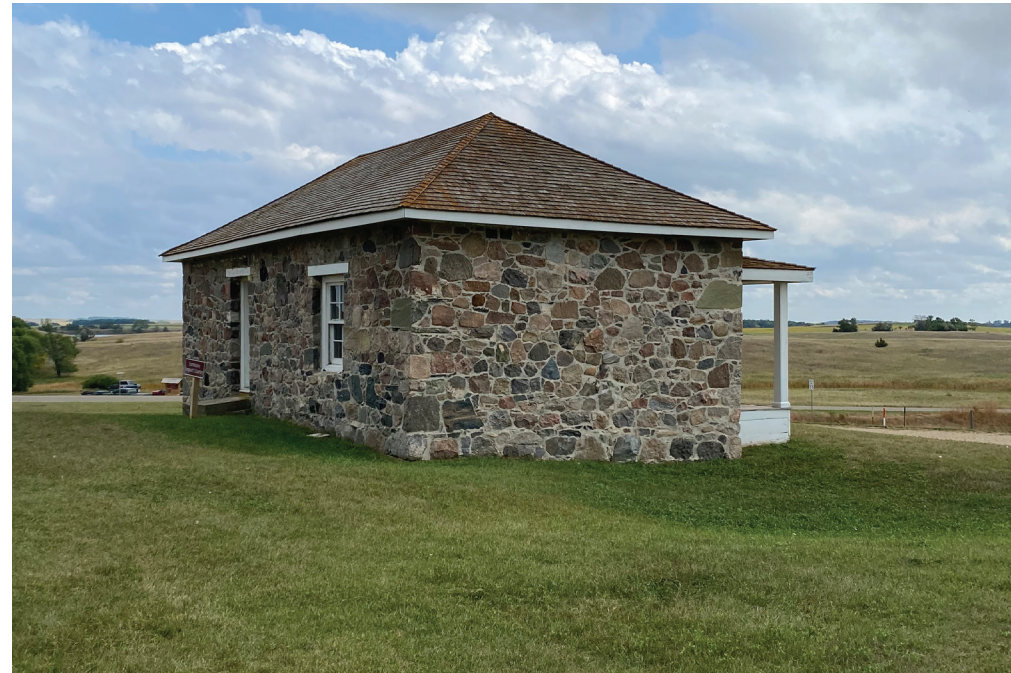
COMMISSARY SERGEANT'S QUARTERS

Located on the south side of the Park, the Commissary Sergeant's headquarters is the only remaining building from the original military construction outside the primary square. Nearby, the foundation for the Quartermaster Sergeant's quarters still remains.

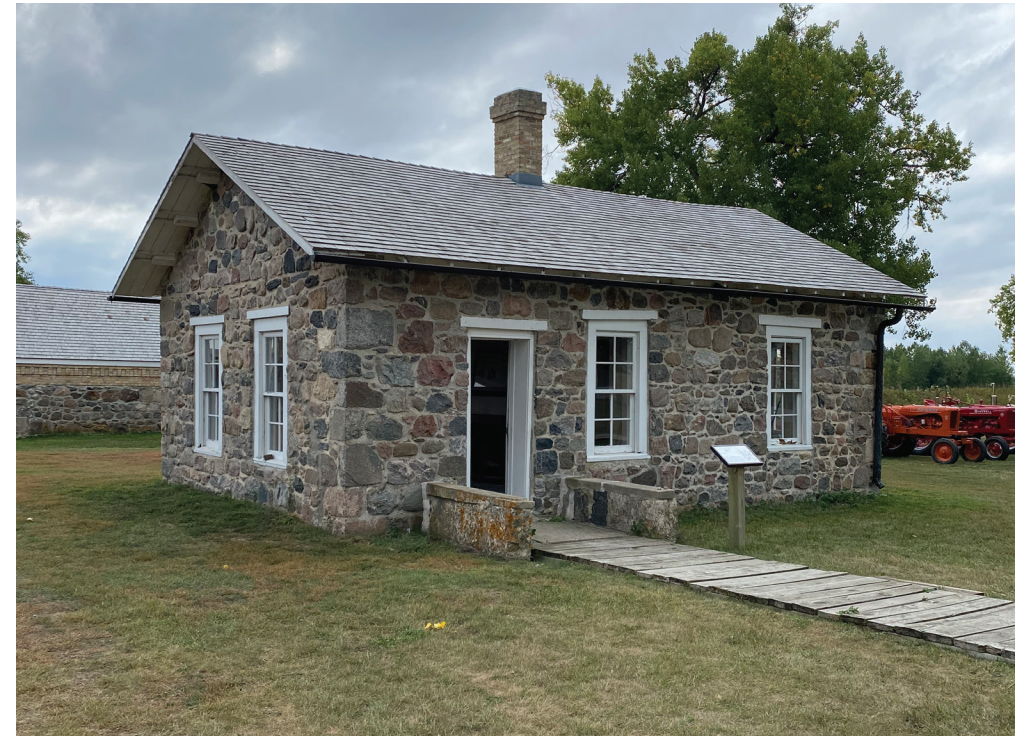
ADJUTANT'S OFFICE

Centrally located in the layout of the Fort, the Adjutant's Office operated as the control center. The Adjutant—a soldier who served as the administrative personal assistant to the commanding officer—was responsible for the correspondence, records, and post orders. Adjutants also handled the pay, and even acted as mediator for enlisted men and officers.

By 1935, the building was close to disrepair. The structure was rebuilt into a dwelling with a partial basement, a gable-type roof, new woodwork and sash, new plastering, and some plumbing.

- Replace & stain all baseboard, window, and door trim
- Repair and paint cracked walls
- Repair mantel
- Reseal cedar shingles on roof

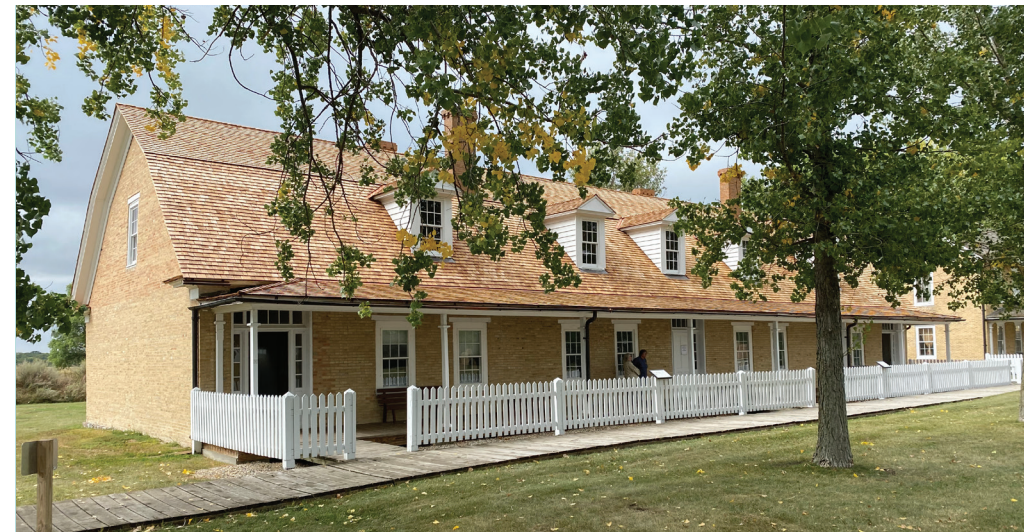
OFFICER'S QUARTERS

The west wall is leaning near the center and may require reconstruction. The north wall requires significant tuckpointing work. A specialist is required for this work.

Some water damage was observed in the upper level, though the recently replaced windows and roofing seem to have addressed this issue.

Divided into four adjoining apartments, the Officer's Quarters served as home and office space for the Fort's officers. Each of the quarters had a small entry hall with a staircase to the upper floors. The large ground floor space had folding doors to partition the space into rooms, each of which had a fireplace and windows. A wood frame kitchen and store room (with the servants' quarters above) were originally located on the west side of each quarter. A covered brick sink (bathrooms) shared with the other quarters was found at the back of the store room. There was a small cellar under each set of quarters. The original mansard roof was later replaced with a gable roof, and the front of the building has been restored to its original appearance.

- Replace lower windows
- Repair rotten floor joists and wooden floor in central apartment
- Repair large cracks and issues in plaster throughout the entire building
- Straighten gutters and paint fascia
- Tuckpointing exterior of building and chimneys

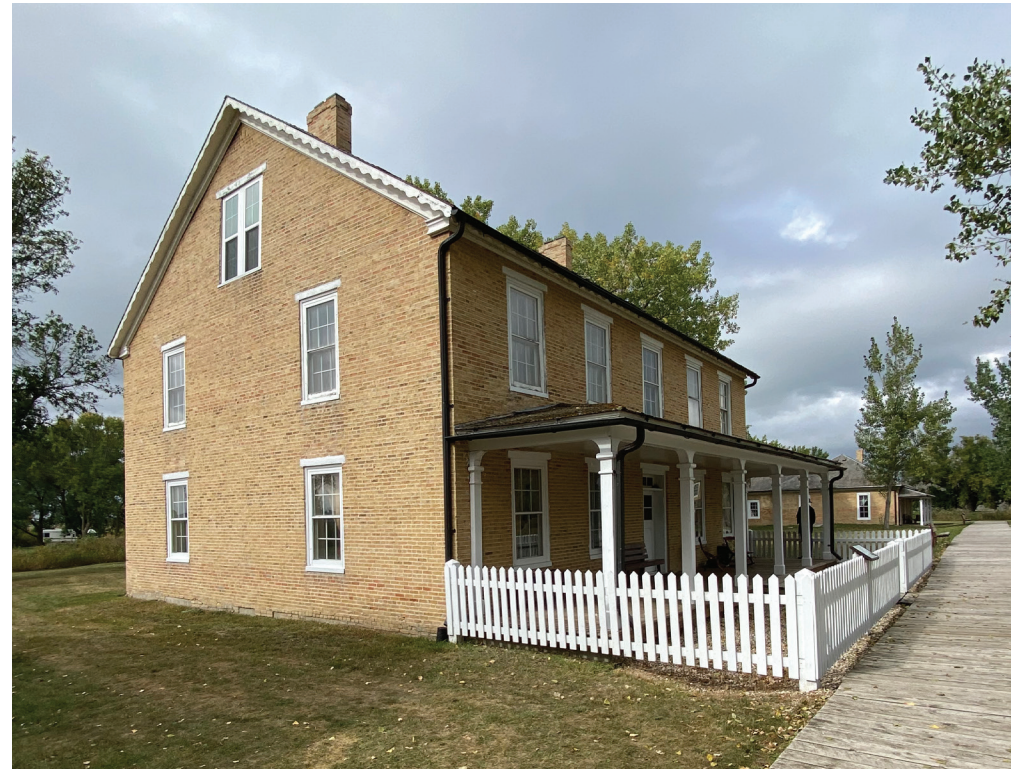
COMMANDING OFFICER'S QUARTERS

The Commanding Officer's Quarters is a two and a half story brick structure. Compared to other nearby structures, the bricks in this building are an unusual shade due to a lack of iron in the clay used for these bricks. Each floor comprises four rooms, and each room has a fireplace and several windows. Servants stayed in the top level where there are two bedrooms and a sitting room. Curiously, records indicate none of the Fort's Commanding Officers (of which there were at least 11) actually lived in this building during the 25 years of military occupancy.

The southwest corner requires tuckpointing work near the ground level. A specialist is required for this work. The downspouts should be directed away from the structure.

- Straighten gutter, repair/replace fascia, and reshingle roof
- Tuckpointing of building
- Stabilize floor due to separation
- Repair cracks in plaster walls

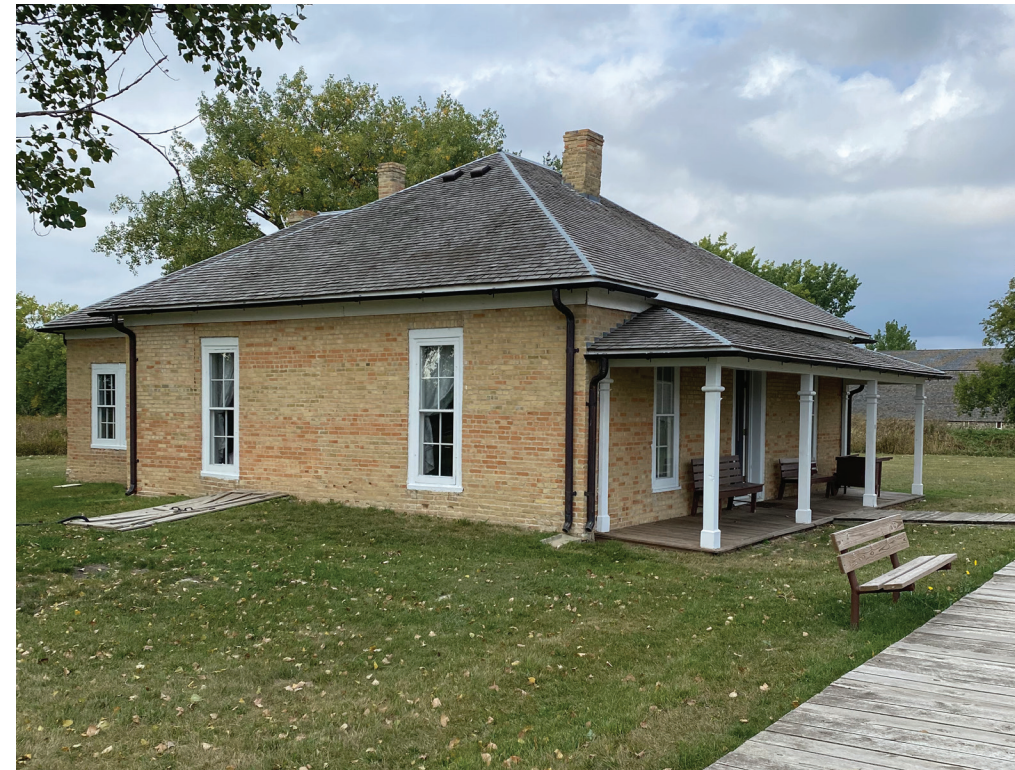
DOCTOR'S QUARTERS

The foundation requires repair, particularly around the penetrations for the geothermal pipes. Minor tuckpointing work is required. A specialist is required for this work.

The Post doctor was responsible for collecting information about the birds, animals, weather, anthropology, and geology for the vicinity. Equipment for recording weather data was located at the front of the building on the left. The doctor's brick-made home is one story tall with a porch on the front. There is also a cellar that used to hold food. The house contained four large rooms with a kitchen and servants' quarters in the rear. A fireplace heated each room. Twenty-six post surgeons, either army officers or civilians, served at the Fort hospital, though there is no record of any living in the Doctor's Quarters.

- Repair north wall (bowing)
- Renovate cellar due to water damage and exposed wiring
- Reseal cedar shingles on roof

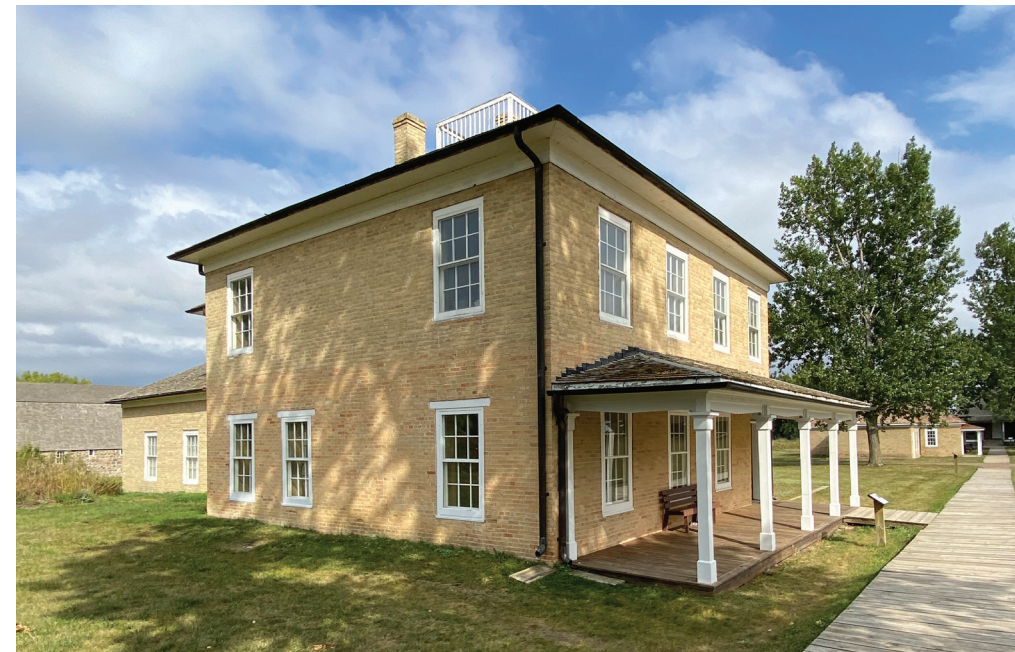
HOSPITAL

Originally, the hospital included an office, a dispensary, a kitchen, two wards, and a washroom. The eastern ward is no longer intact, though the concrete foundation is visible. The second level includes a store room for patients' personal effects, dormitories for the hospital attendants, and a bedroom and sitting room for the hospital matron. In 1935, the northeast wall of the ward was badly damaged. Rather than repair the wall, the bricks were reused to replace an inside wall, and new bricks finished the wall. The bricks for the refinished exterior wall vary in color. Today, the porch is shorter than the original in 1868 due to the loss of the east ward.

- Tuckpointing on the building exterior and chimney
- Replace cedar shingles, replace fascia, and straighten gutters

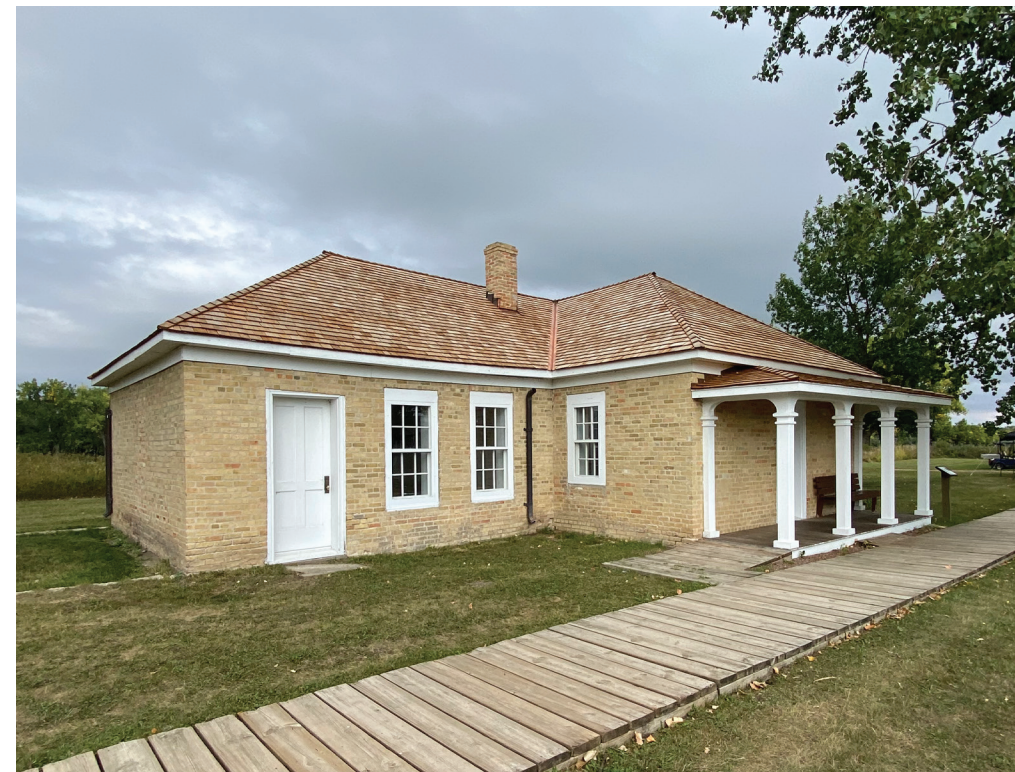
LIBRARY - SCHOOLHOUSE

A log structure served as a schoolhouse until this brick and mortar building replaced it in 1881. This building was built in a cross design, originally housing a 94-volume library, a school, and a room for official court-martial proceedings. On Sundays the schoolroom was used for religious services. In 1880, a telephone and telegraph line was installed connecting Fort Sisseton and the Webster telegraph station. The telegraph office was attached to the west side of the library in the marked foundation, and routed into an office for the telegraph.

- Replace windows
- Tuckpointing of building exterior

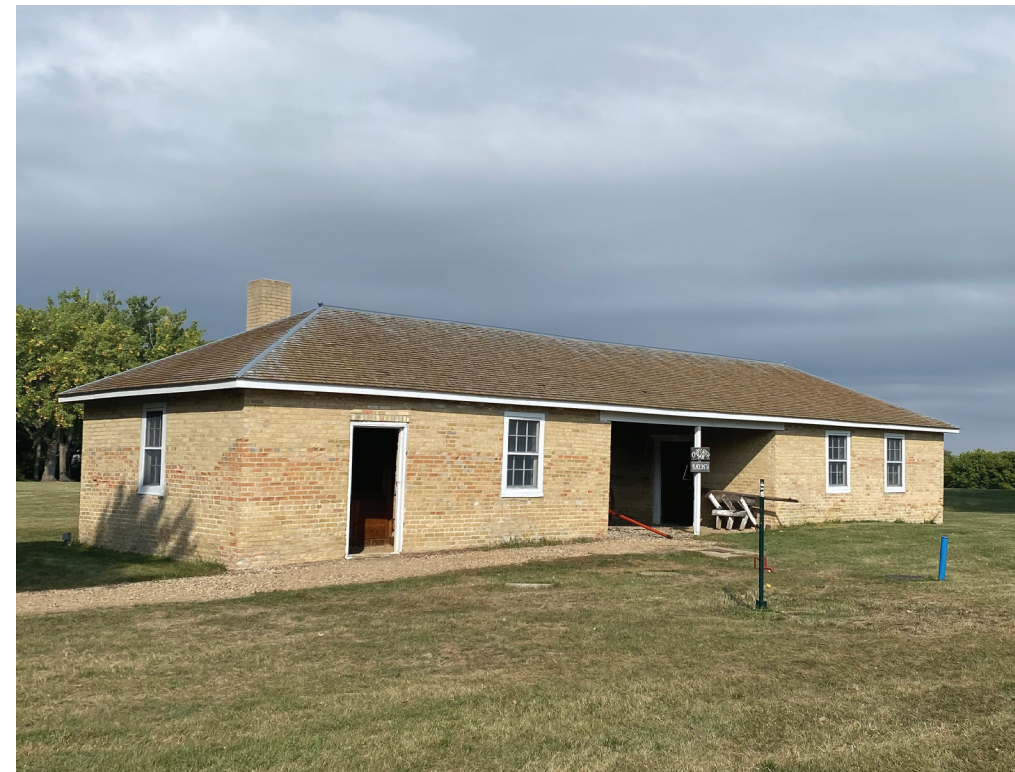
CARPENTER - BLACKSMITH SHOP

Tuckpointing work is required throughout the structure, and it is significant in some areas. A specialist is required for this work. Some of the bricks are spalled. Continue monitoring for further spalling and other signs of damage / deterioration.

In 1881, enlisted personnel constructed a new blacksmith shop and a carpenter shop. The gap between the two structures is covered by a single roof that covers both shops and the shared space between them. After the Fort's military decommission, this structure laid in ruins until the WPA started reconstructing the buildings in 1935. Today, Park visitors can view a display of blacksmith and wheelwright tools from the 1800s, along with reenactments of people working in these buildings during events.

- Tuckpointing exterior of building
- Replace windows
- Reshingle roof

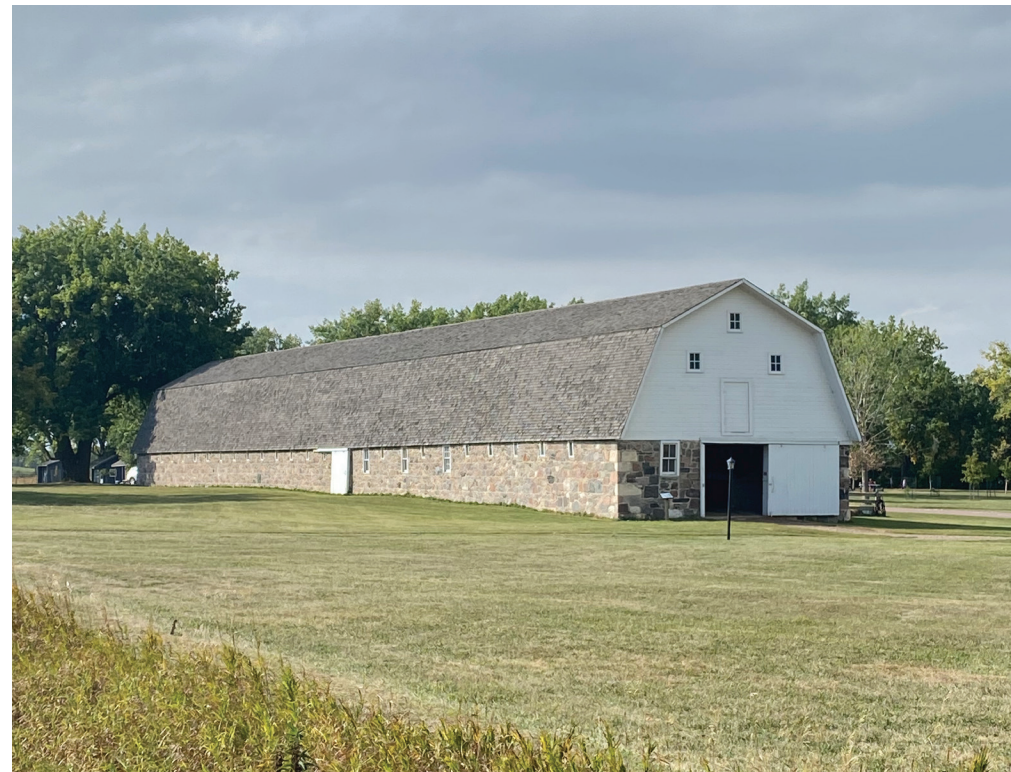
BARN

Roof repairs will likely be required in the near future. Along with the age of the roof, it has become a target for woodpeckers that leave several compromising holes. There is already noteworthy water staining in the upper level.

Fort Sisseton was primarily a cavalry post with four companies until June 1866, and they needed a place to safely shelter their horses. The stable was constructed of split fieldstone and contains 78 stalls. The original structure had a gable roof, hinged doors, a chimney (in the southeast corner), and quarters for the Cavalry Sergeant. The present building was the work of the WPA during reconstruction in 1935. Several local riding clubs leased the building to shelter their horses prior to the Fort becoming a State Park in 1959.

- Replace shower heads/handles in handicap stalls of comfort stations
- Repair floor in front of men's restroom in comfort stations
- Scrape and paint shower stalls in comfort stations
- Stabilize second floor
- Upgrade electrical
- Paint barn
- Reshingle roof
